THICKNESS REQUIREMENTS FOR SOILS BENEATH
LANDING MATS; BARE BASE SUPPORT

MISCELLANEOUS PAPER S-71-3

Project 3782-64

H. H. Ulery, Jr., D. P. Wolf

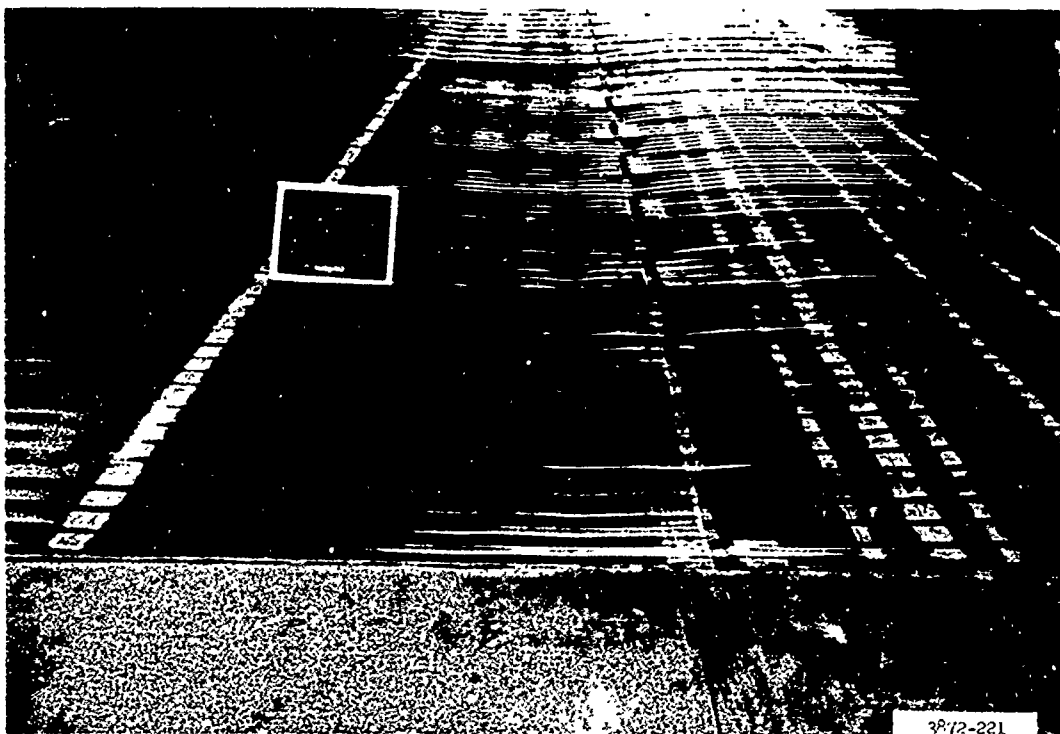
3. Item 1. A view of item 1 prior to traffic is shown in photograph A1. There was considerable permanent deformation of the mat with the application of traffic, and by 10 coverages, longitudinal deformation averaged about 1.9 in. Traffic was continued to 30 coverages, at which time item 1 was considered failed due to excessive roughness. At failure, three panels had cover-plate weld breaks. Photograph A2 shows permanent deformation of 3.2 in. at one location; average deformation was about 2.3 in. for the test item at 30 coverages. An overall view of item 1 at failure is shown in photograph A3.

Photograph A3. Test section I, lane 1, item 1,
after failure at 30 coverages

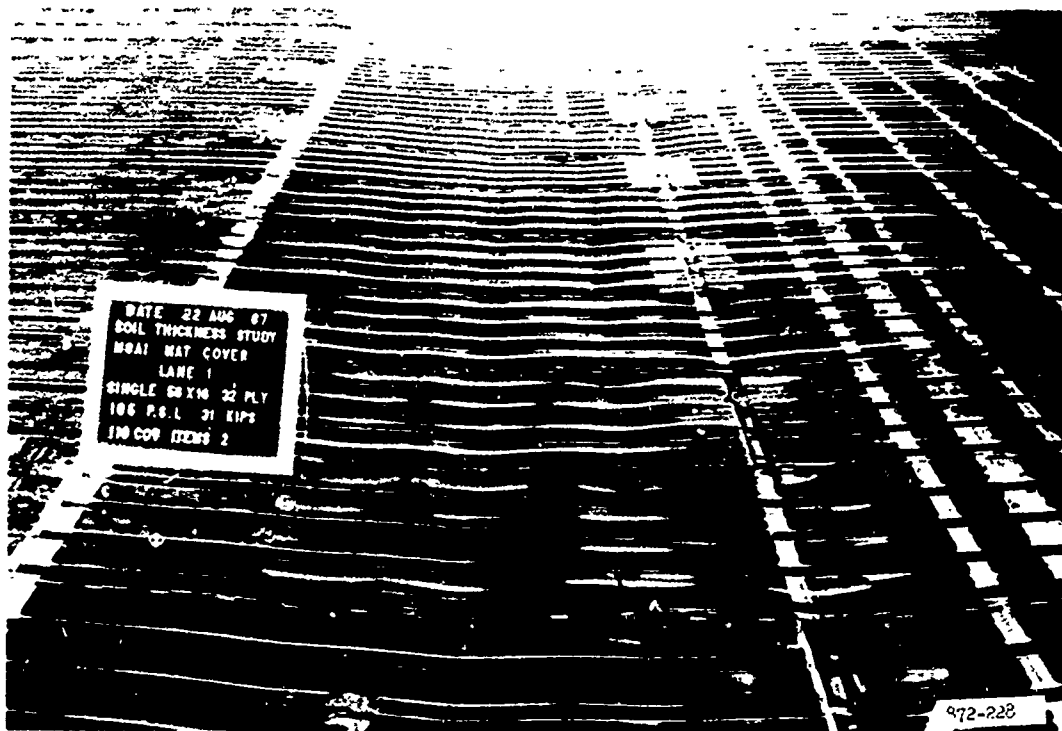
70 coverages with the occurrence of locking-lug breaks. At 110 coverages, six locking lugs had broken, and permanent deformation and roughness had become excessive. Item 2 was considered failed at 110 coverages, and an overall view of the item at failure is shown in photograph A5.

Photograph A5. Test section I, lane 1, item 2,
after failure at 110 coverages

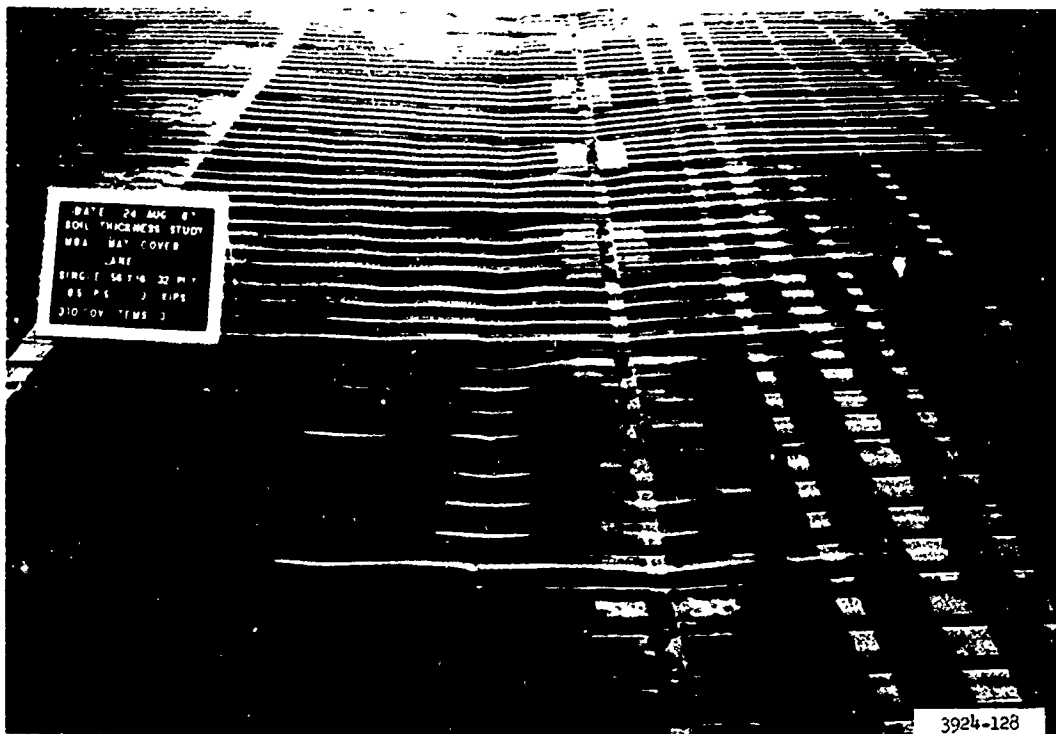
5. Item 3. An overall view of item 3 prior to traffic is shown in photograph A6. Deformation of the mat, which did not deform so rapidly as that in items 1 and 2, averaged about 0.8 in. after 30 coverages. Deformation increased very slowly with increased traffic. Mat breakage was first observed at approximately 170 coverages with the occurrence of two locking-lug breaks. As traffic continued, mat breakage and deformation increased rapidly, and at 310 coverages, item 3 was considered failed. Deformation at failure averaged about 2 in. Failure was due primarily to mat breakage. An overall view of item 3 at failure is shown in photograph A7.

Photograph A7. Test section I, lane 1, item 3,
after failure at 310 coverages

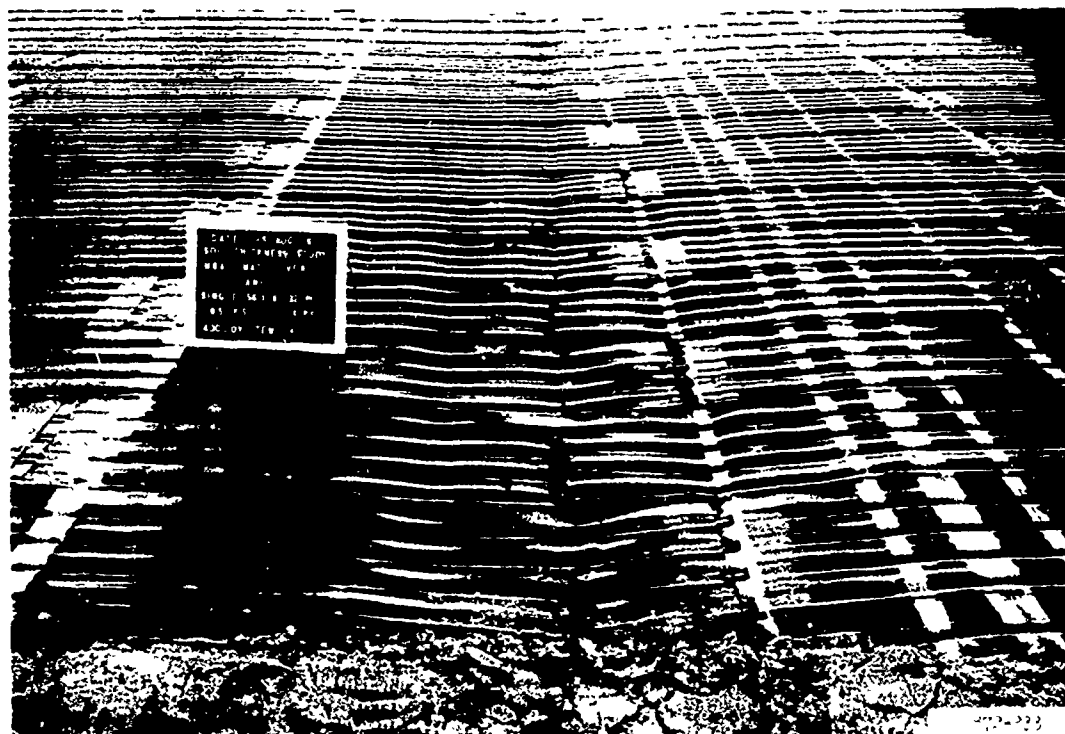
6. Item 4. An overall view of item 4 prior to traffic is shown in photograph A8. Permanent mat deformation developed slowly during the application of traffic. The first mat breakage, locking-lug breaks, was observed at approximately 230 coverages. Mat breakage progressed with increased traffic, and after 430 coverages, item 4 was considered failed due to excessive mat breakage. Photograph A9 shows a typical locking-lug break, and an overall view of item 4 at failure is shown in photograph A10.

Photograph A10. Test section I, lane 1, item 4,
after failure at 430 coverages

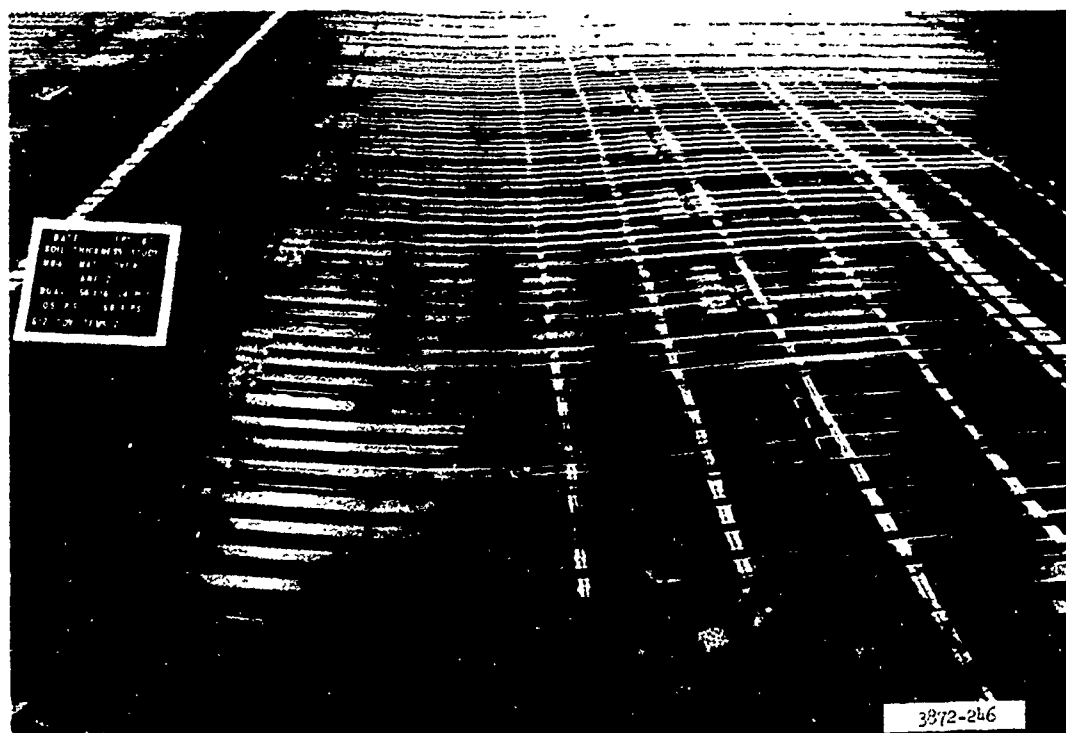
10. Item 2. An overall view of item 2 prior to traffic is shown in photograph A13. Permanent deformation of the mat developed very slowly with the application of traffic. By 120 coverages, longitudinal deformation averaged about 1.0 in. Mat breakage was first observed at 360 coverages. Breakage developed slowly, and after 612 coverages, only three breaks were observed. At this time, item 2 was considered failed because of excessive roughness. An overall view of item 2 at failure is shown in photograph A14.

Photograph A14. Test section I, lane 2, item 2,
after failure at 612 coverages

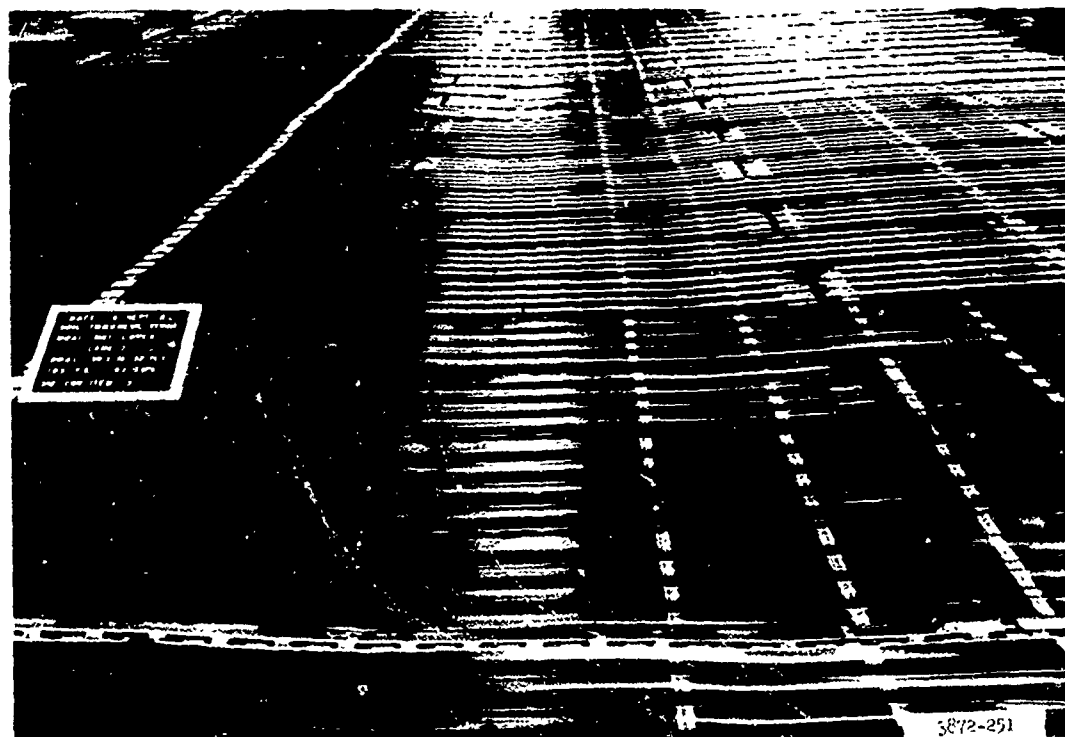
11. Item 3. An overall view of item 3 prior to traffic is shown in photograph A15. No apparent distress was observed in item 3 during 612 coverages. After 612 coverages, the test load was increased from 56,000 to 62,000 lb, and the tire inflation pressure was increased from 105 to 185 psi. Photograph A16 shows item 3 at 612 coverages prior to trafficking with the revised test load. The first sign of distress, a locking-lug break, was noted after an additional 192 coverages had been applied. After 312 additional coverages (924 coverages of mixed traffic), tire hazards had developed from excessive mat breakage, as shown in photograph A17, and item 3 was considered failed. An overall view of item 3 at failure is shown in photograph A18. Item 3 received a total of 924 coverages.

Photograph A18. Test section I, lane 2, item 3, after failure at 924 coverages of mixed traffic

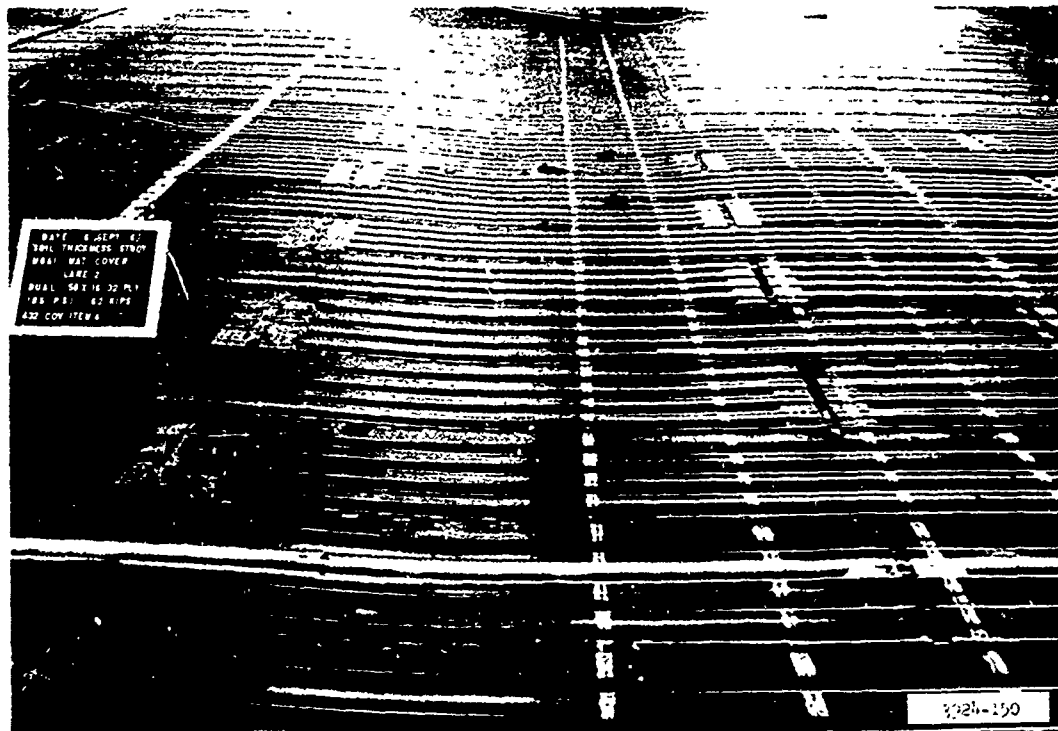
12. Item 4. An overall view of item 4 prior to traffic is shown in photograph A19. The mat showed no signs of distress by 612 coverages, and additional traffic was applied with the revised load described in the preceding paragraph. After an additional 288 coverages, the first mat break was observed. After 350 additional coverages, mat breakage began to develop rapidly, and after 432 additional coverages (1044 total coverages), item 4 had developed serious tire hazards and was considered failed. An overall view of item 4 at failure is shown in photograph A20. Item 4 received a total of 1044 coverages.

Photograph A20. Test section I, lane 2, item 4, after failure at 1044 coverages of mixed traffic

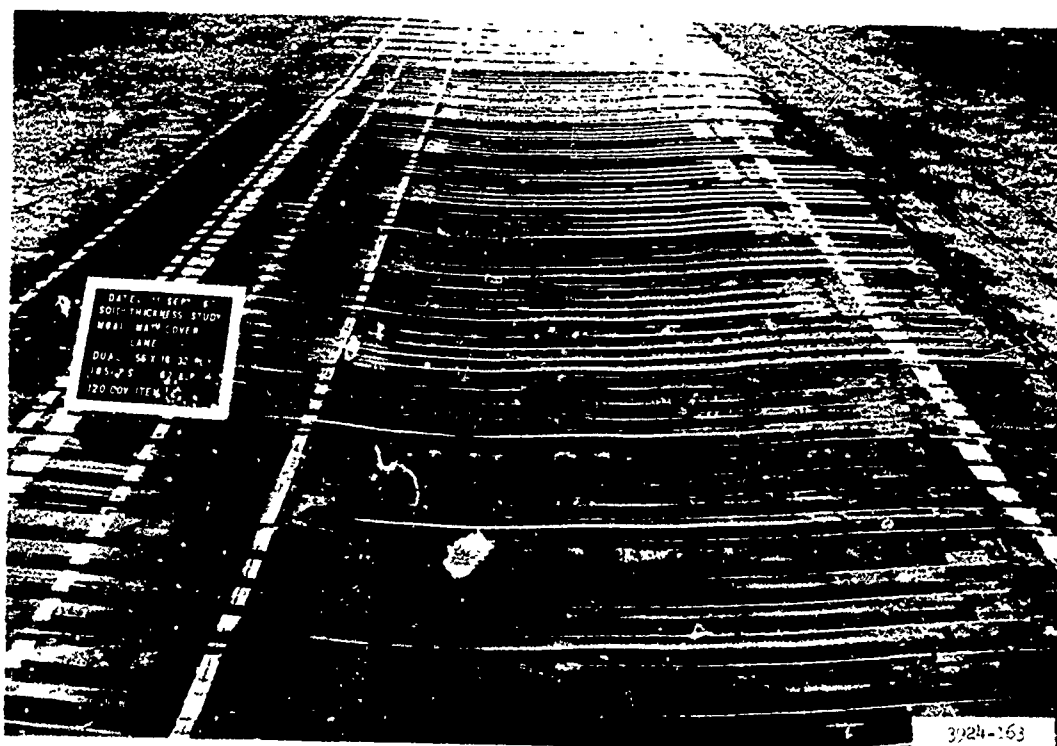
16. Item 2. An overall view of item 2 prior to traffic is shown in photograph A21. As traffic was applied, permanent deformation of the mat was fairly rapid, and after 120 coverages, item 2 was considered failed due to excessive roughness. There was no mat breakage at failure. An overall view of item 2 at failure is shown in photograph A22.

Photograph A22. Test section I, lane 3, item 2, after failure at 120 coverages

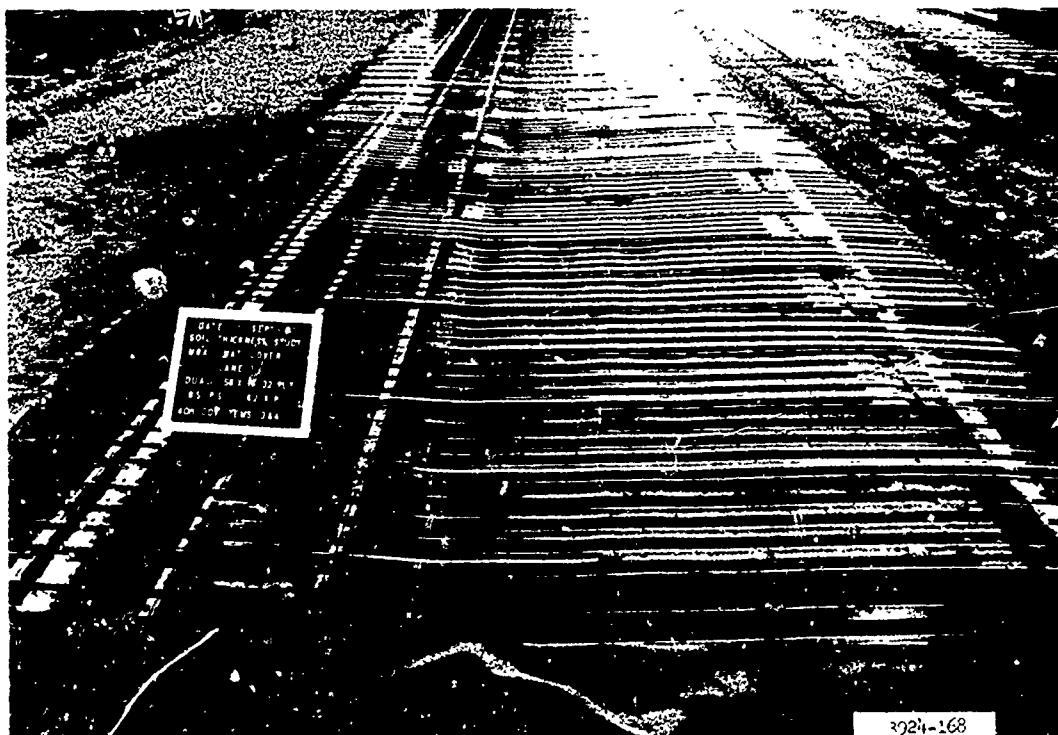
17. Item 3. An overall view of item 3 prior to traffic is shown in photograph A23. Permanent deformation developed slowly with continued traffic. The first mat breakage was observed at 228 coverages. Traffic was continued to 408 coverages, at which time item 3 was considered failed due to excessive roughness. An overall view of item 3 at failure is shown in photograph A24.

Photograph A24. Test section I, lane 3, item 3,
after failure at 408 coverages

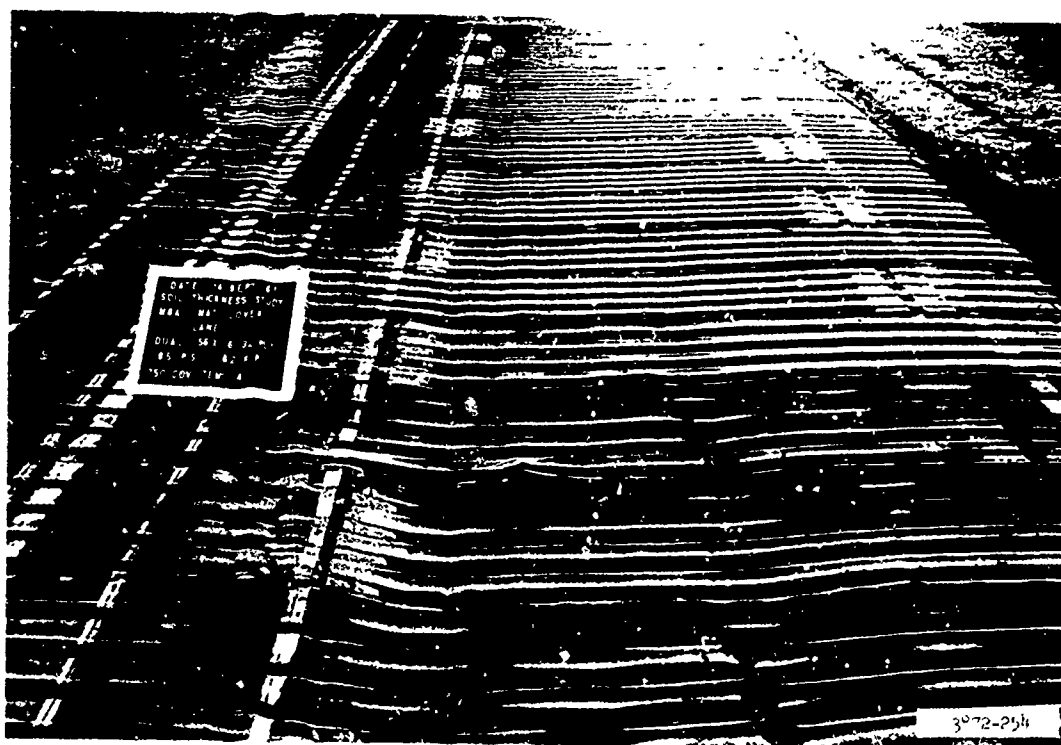
18. Item 4. An overall view of item 4 prior to traffic is shown in photograph A25. Mat deformation developed slowly, and the first mat breakage was observed at approximately 385 coverages. With increased traffic, roughness began to develop, and at 750 coverages, item 4 was failed due to excessive roughness and tire hazards caused by mat breakage. An overall view of item 4 at failure is shown in photograph A26.

Photograph A26. Test section I, lane 3, item 4,
after failure at 750 coverages

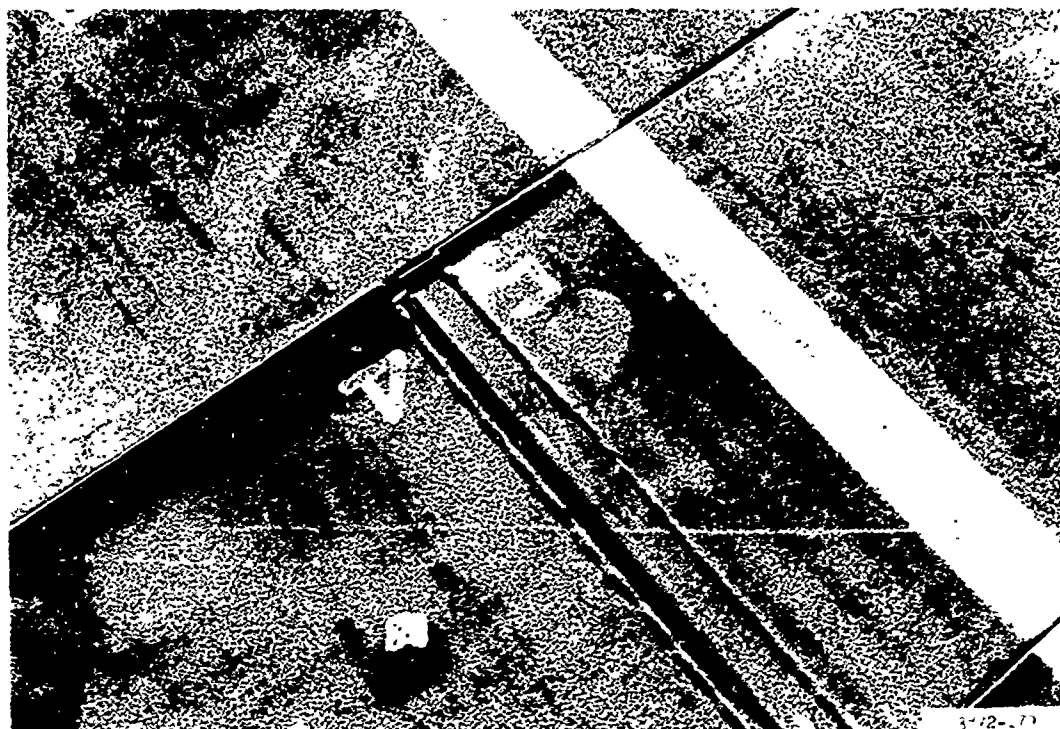
Photograph A30. Damaged C-rail of panel 4, test section II, lane 1, item 1, after 54 coverages

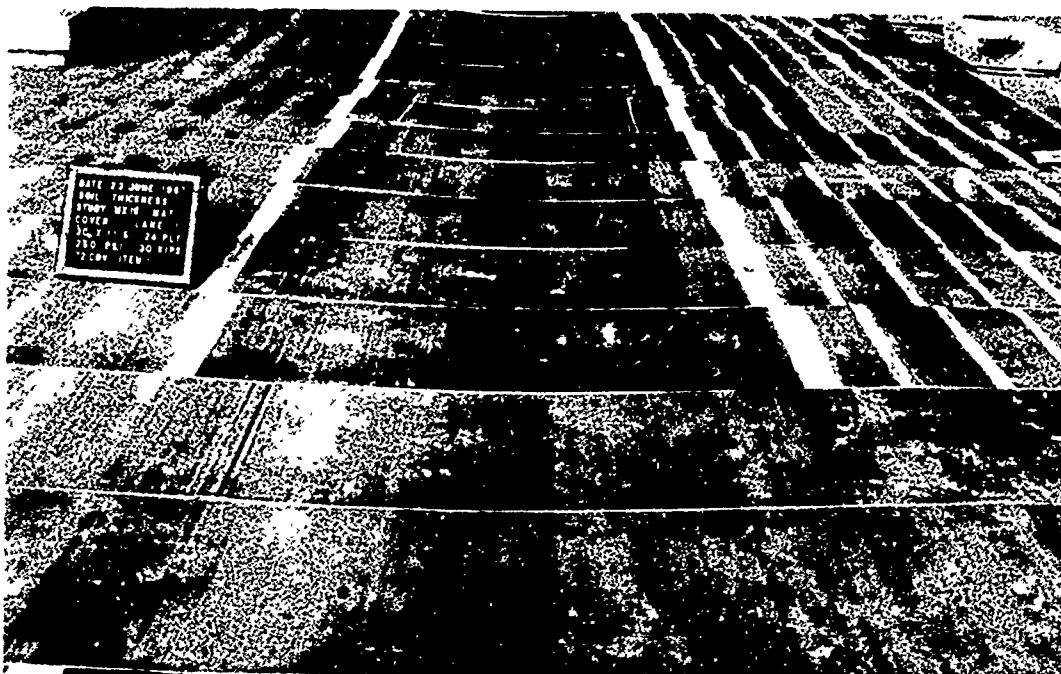
22. Item 1. An overall view of item 1 prior to traffic is shown in photograph A27. Mat roughness in item 1 was observed after three coverages, and after 12 coverages, dishing measured 0.75 in. in the transverse direction in one location, as shown in photograph A28. Photograph A29 shows longitudinal deformation of about 1 in., as measured on panel 13. By 32 coverages, the bottom lip of the overlapping end joint in panel 5 had sheared off, causing panel 4 to deflect under the wheel load. After 54 coverages, the C-rail of panel 4 was extensively damaged (see photograph A30), and panels 4 and 5 were replaced. After 72 coverages, item 1 was considered failed due to excessive roughness. An overall view of item 1 at failure is shown in photograph A31.

Photograph A31. Test section II, lane 1, item 1,
after failure at 72 coverages

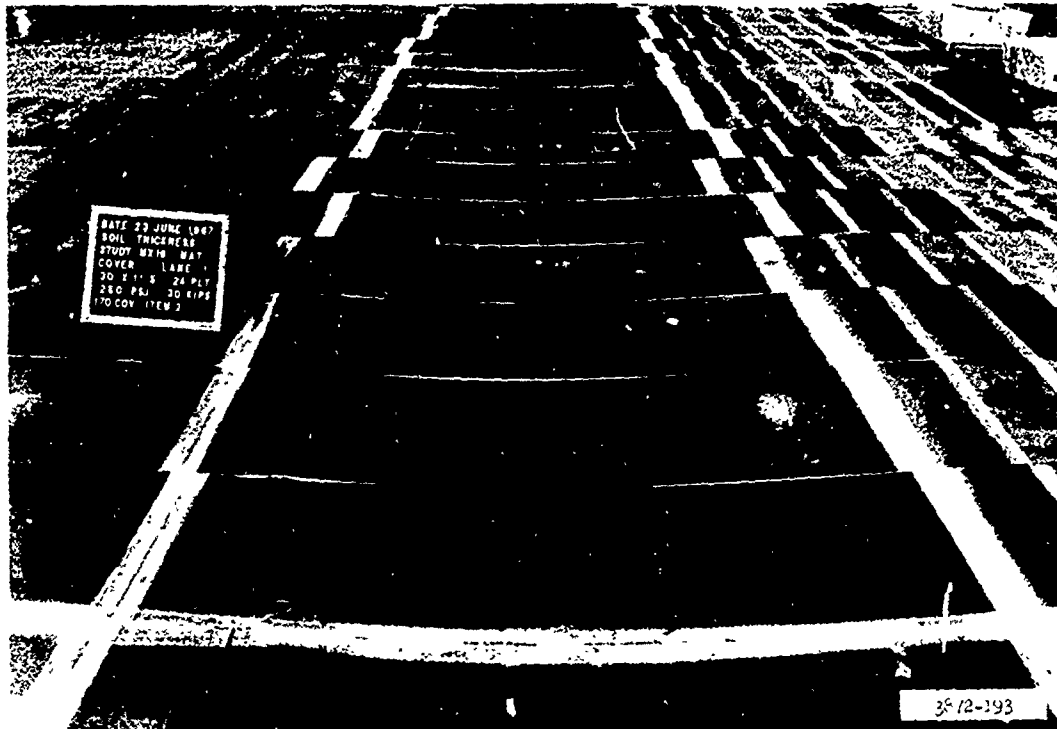
23. Item 2. An overall view of item 2 prior to traffic is shown in photograph A32. Permanent mat deformation was observed at approximately eight coverages. By 100 coverages, longitudinal deformation averaged about 1.7 in. After 170 coverages, item 2 was considered failed due to excessive roughness. Longitudinal deformation at failure averaged 1.8 in. No mat breakage was observed in item 2 throughout the period of traffic. An overall view of item 2 at failure is shown in photograph A33.

Photograph A33. Test section II, lane 1, item 2,
after failure at 170 coverages

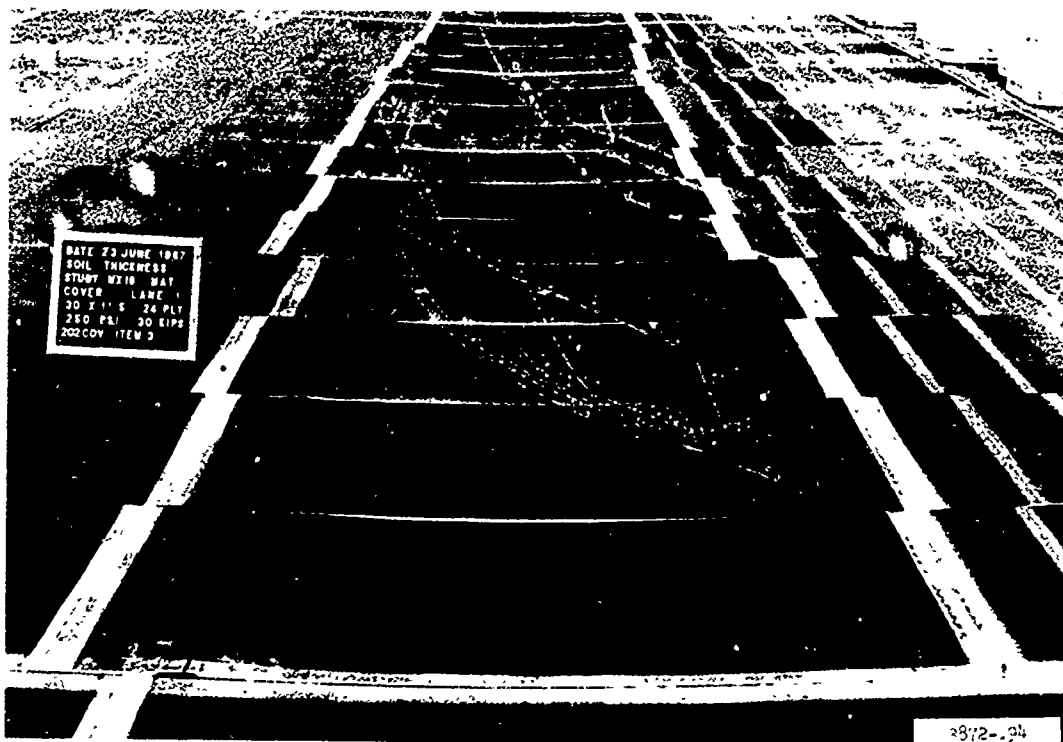
photograph A34. Permanent mat deformation, observed initially after several coverages, increased slowly with continued traffic. By 100 coverages, longitudinal deformation averaged 1.0 in. The first sign of mat breakage, an internal rib failure, was observed at 142 coverages. After 202 coverages, item 3 was considered failed due to excessive roughness caused by subgrade deformation. An overall view of item 3 at failure is shown in photograph A35.

Photograph A35. Test section II, lane 1, item 3,
after failure at 202 coverages

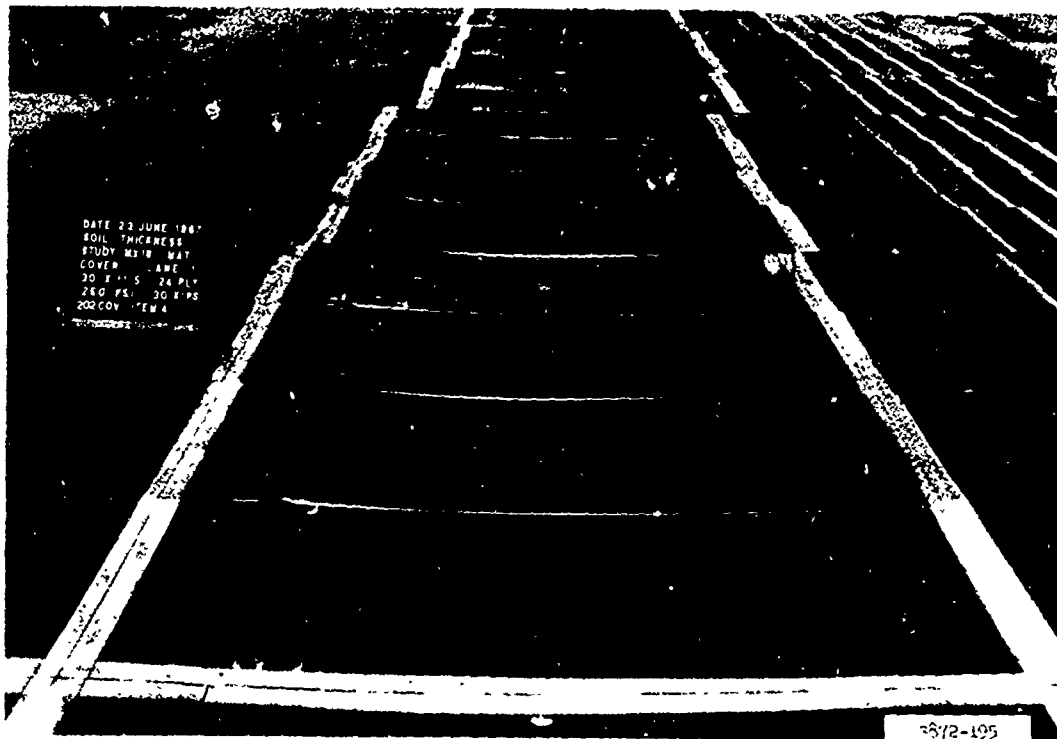
25. Item 4. An overall view of item 4 prior to traffic is shown in photograph A36. Permanent mat deformation developed slowly as traffic was applied. Longitudinal deformation averaged 1.3 in. after 100 coverages and increased to 2.5 in. by 202 coverages. After 202 coverages, item 4 was considered failed due to excessive deformation of the mat. At failure one panel was observed with internal rib failures, and one panel was observed with a damaged C-rail. An overall view of item 4 at failure is shown in photograph A37.

Photograph A37. Test section II, lane 1, item 4,
after failure at 202 coverages

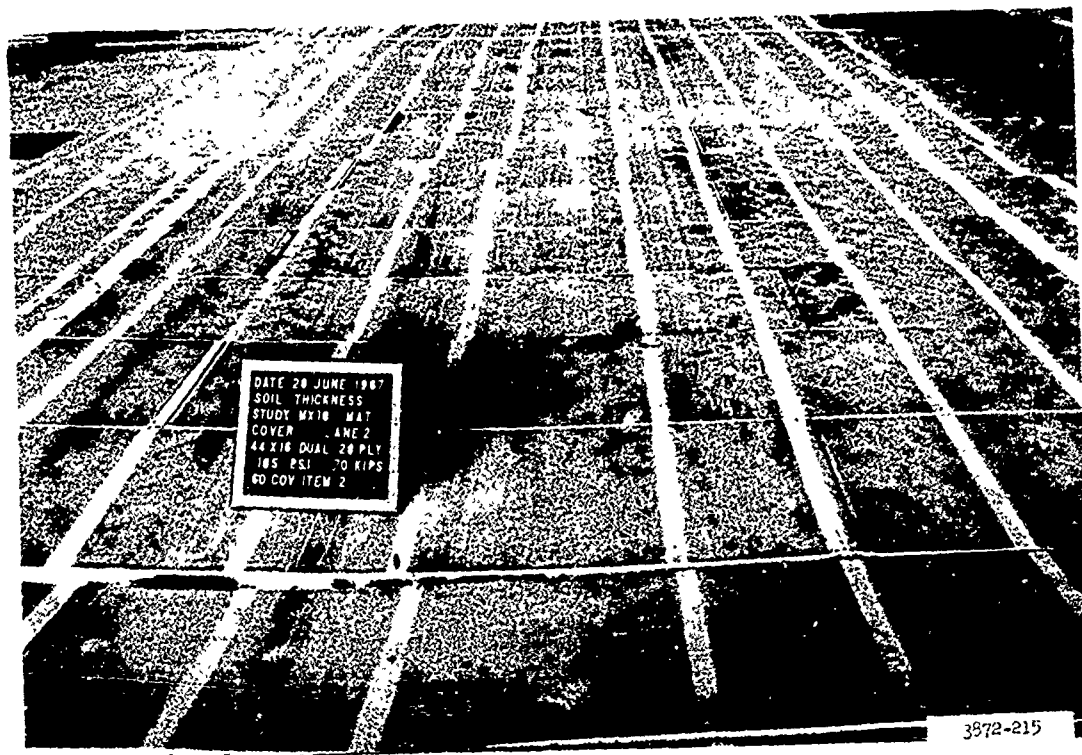
29. Item 2. An overall view of item 2 prior to traffic is shown in photograph A41. Longitudinal deformation measured 1.13 in. after 32 coverages. Mat breakage was first observed after 48 coverages. The bottom lip of an overlapping end joint had sheared on one panel, and two panels had disconnected along the C-rail and male connectors. Item 2 was considered failed after 60 coverages due to excessive deformation and mat breakage. Photograph A42 shows a typical overlapping end-joint failure. An overall view of item 2 at failure is shown in photograph A43.

Photograph A43. Test section II, lane 2, item 2,
 after failure at 60 coverages

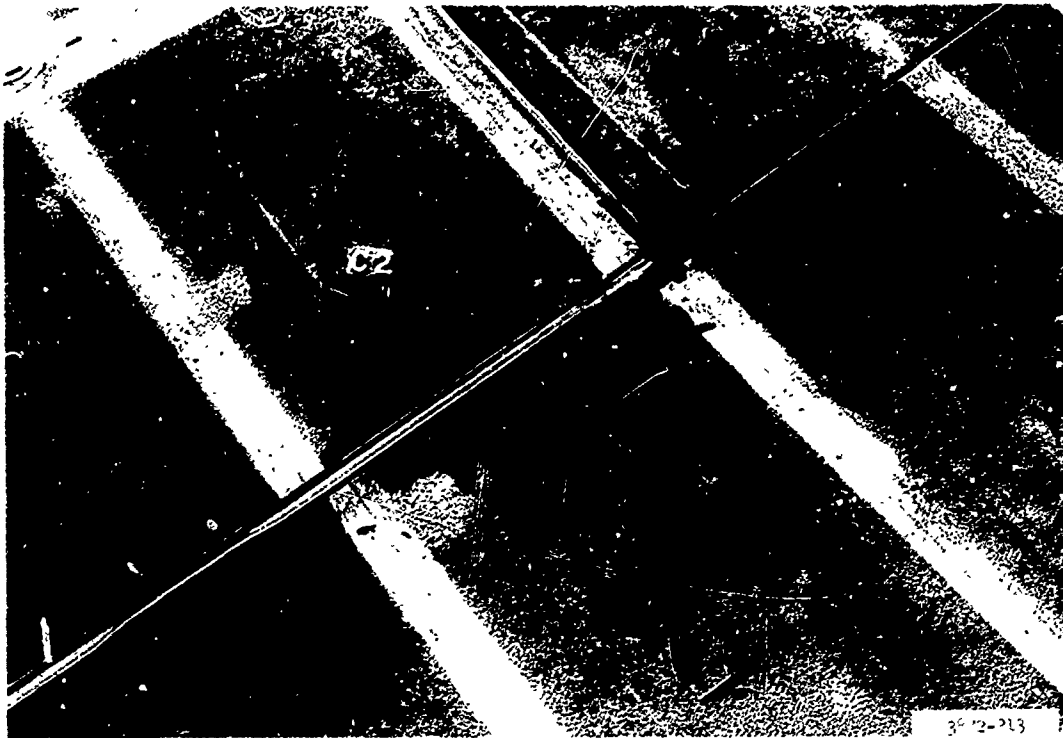
Photograph A45. Typical longitudinal and end-joint failure

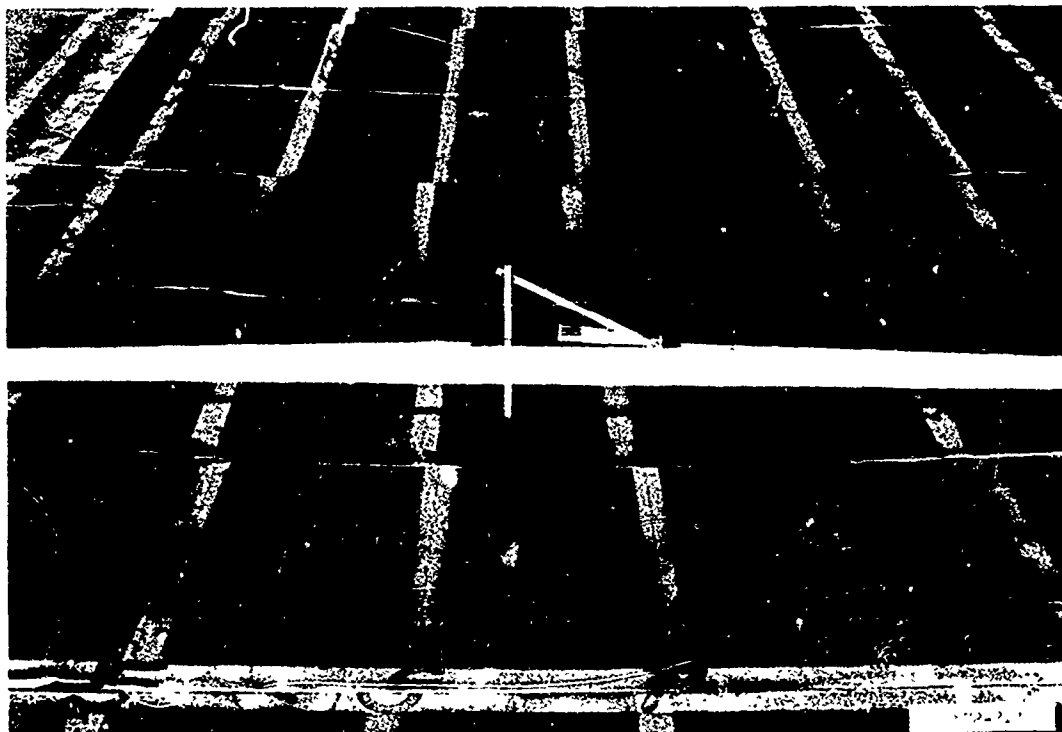
Photograph A46. Longitudinal deformation of 3.1 in. after 144 coverages

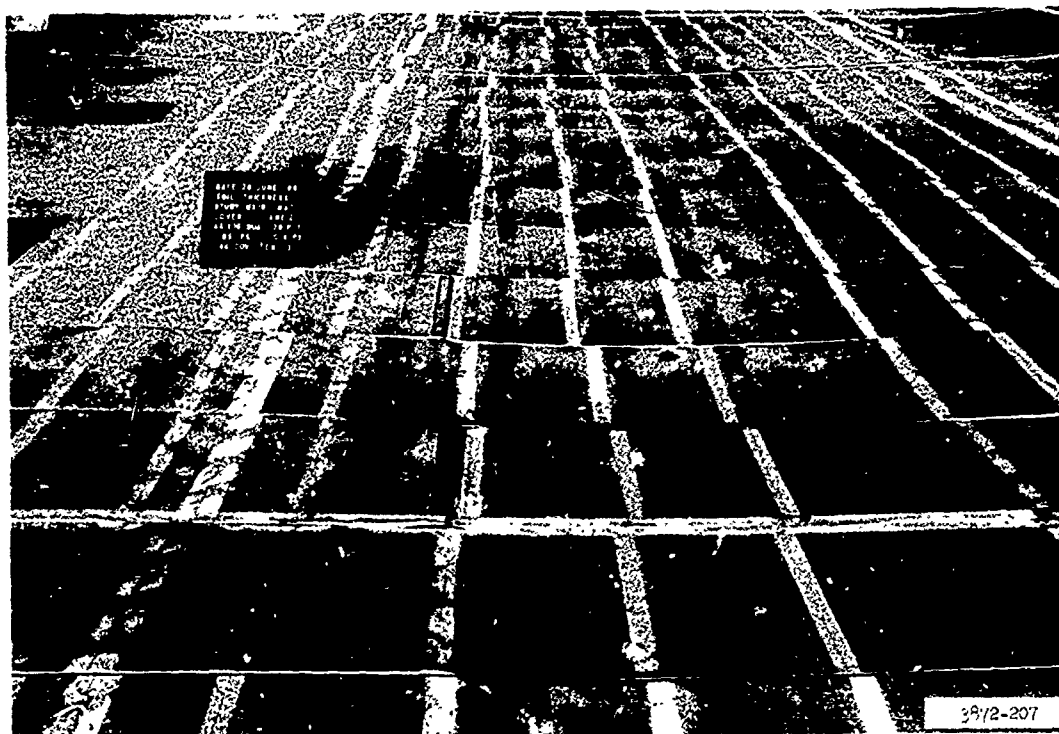
30. Item 3. An overall view of item 3 prior to traffic is shown in photograph A44. No serious mat damage occurred in item 3 during the first 60 coverages; however, longitudinal deformation averaged 1.2 in. The first mat failure occurred at 120 coverages, at which time two panels had disconnected along the C-rail and male connectors. By 144 coverages, excessive mat breakage, as shown in photograph A45, had occurred and longitudinal deformation had increased to 3.1 in., as shown in photograph A46. Failure of item 3 at this coverage level was attributed to excessive mat deformation and mat breakage caused by subgrade deformation. An overall view of item 3 at failure is shown in photograph A47.

Photograph A47. Test section II, lane 2, item 3,
after failure at 144 coverages

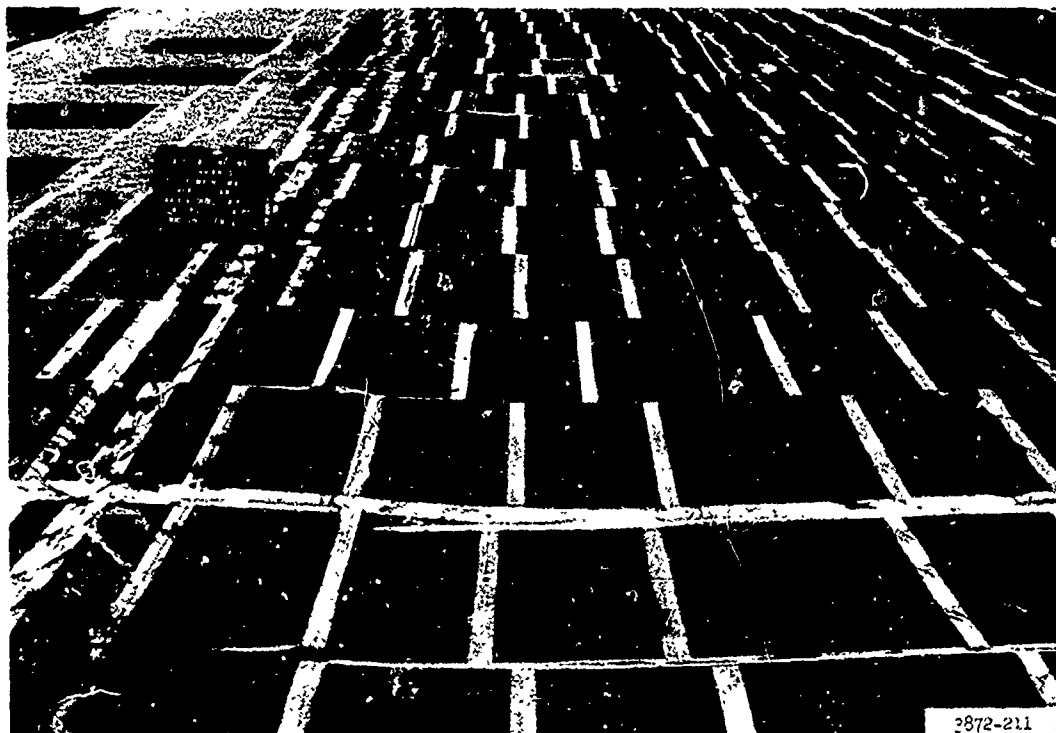
31. Item 4. An overall view of item 4 prior to traffic is shown in photograph A48. Little deformation and no mat breakage were observed in item 4 prior to 144 coverages. At 228 coverages, the bottom lip of an overlapping end connector sheared. Permanent deformation started to develop very rapidly after 228 coverages, and after 300 coverages, item 4 was considered failed due to excessive longitudinal deformation (2.8 in., see photograph A49) and mat breakage. An overall view of item 4 at failure is shown in photograph A50.

Photograph A50. Test section II, lane 2, item 4,
after failure at 300 coverages

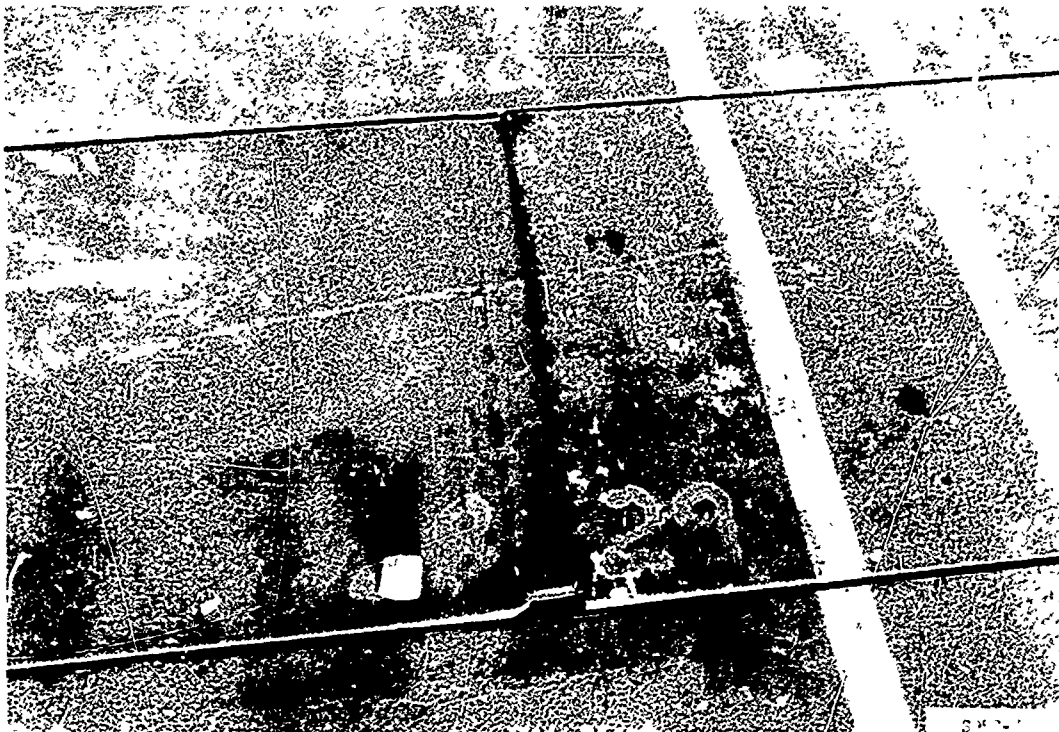
Photograph A52. Weld crack along underlapping end joint after 200 coverage.

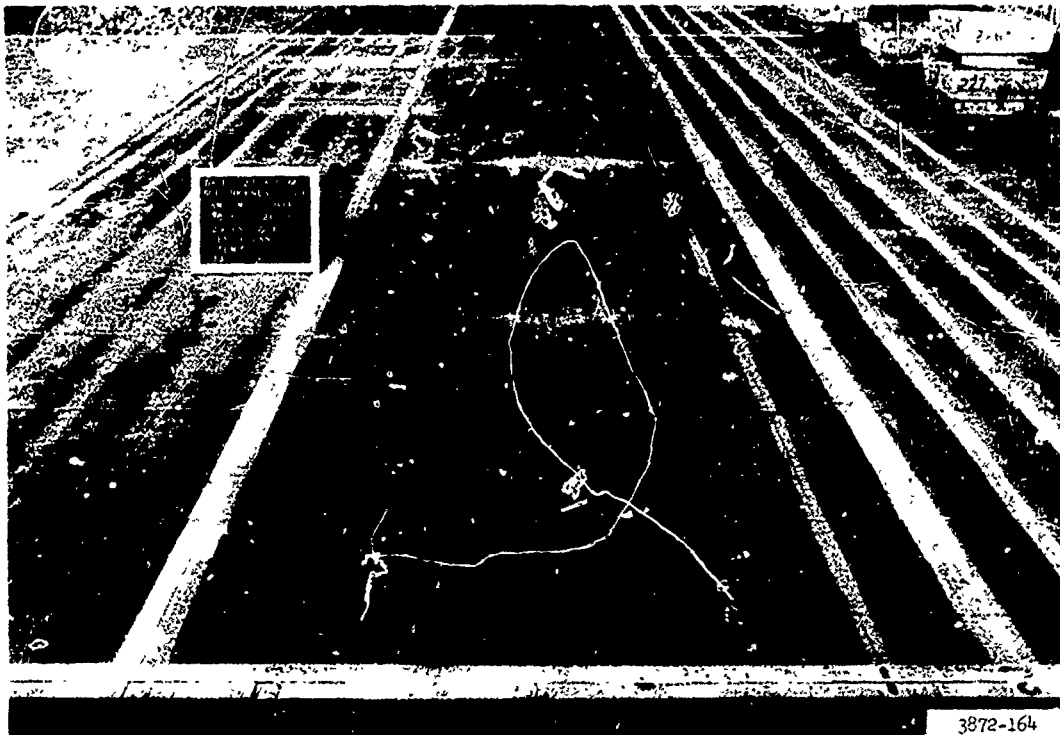
17. A plan and profile of test section V are shown in plate 5. The test section consisted of one test item and was surfaced with one-, two-, and three-piece AM2 landing mat and was trafficked with a 25,000-lb single-wheel load utilizing a 30x11.5 tire with an inflation pressure of 250 psi. The section failed after 330 coverages. The CBR's of the subgrade and the strengthening layer were 3.7 and 5, respectively.

Photograph A77. Test section V after failure at 330 coverages
